October 31st, 2019

Re: Visual Structural Inspection of Brick Water Tower Located on Lindenwood University Campus
Near Cobbs Hall and the Spellman Center

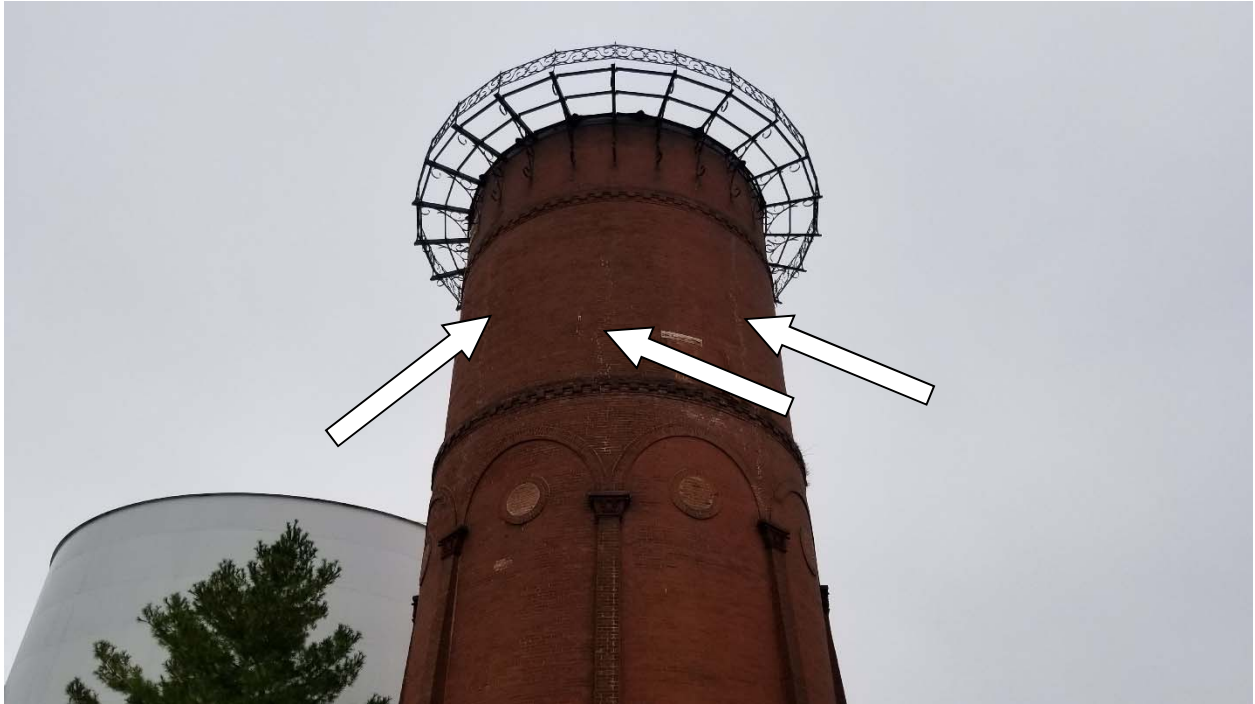
Photograph #1 – Photograph of vertical cracks on exterior surface of brick masonry around perimeter of water tower

- The existing tower structure is in poor overall condition. Considering that the exterior walls of the tower are constructed with deteriorated unreinforced masonry, the structure is highly susceptible to damage from wind and seismic forces. Due to the large physical dimensions of the water tower and its proximity to the Lindenwood University parking lots and the adjacent city water storage tanks, it is my opinion that the tower's current condition represents a potential safety hazard. Additionally, it is also my opinion that repair or rehabilitation of the existing structure would not be economically feasible due to the extent of the deterioration observed. I recommend hiring a demolition contractor to completely demolish the existing water tower.

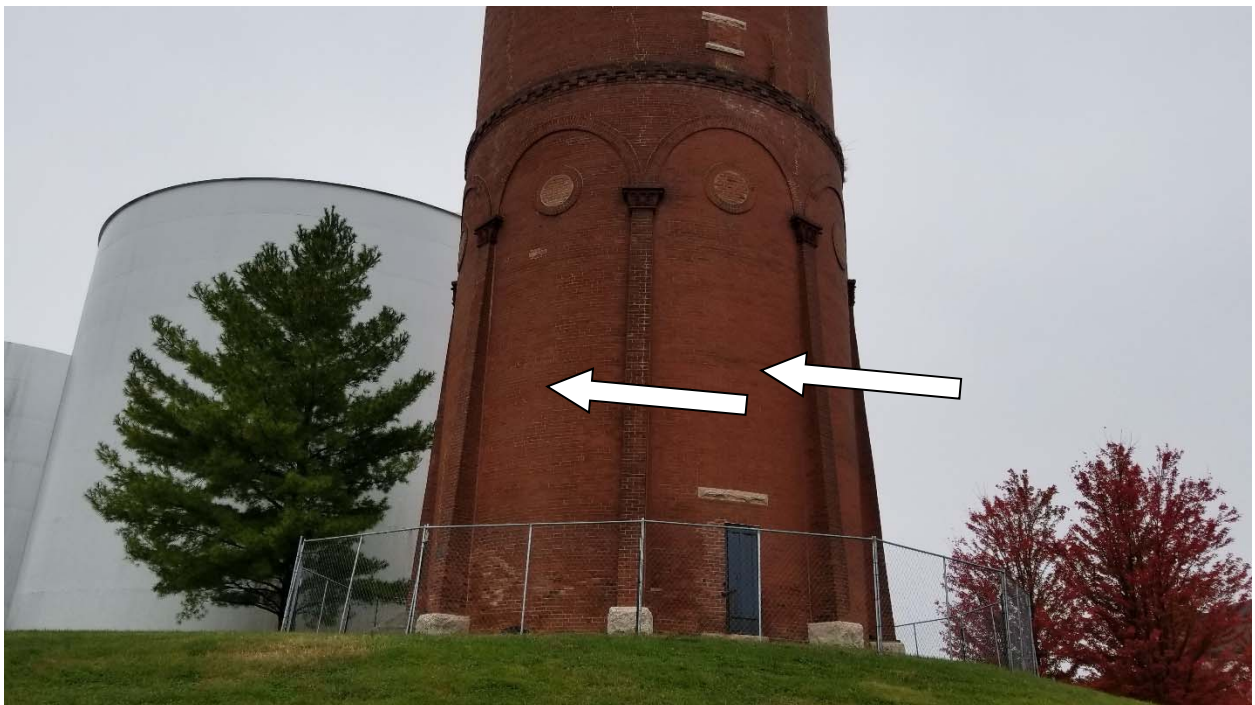
Photograph #2 – Photograph of approximate location of lateral bowing observed in exterior masonry walls. The bowing was observed around the perimeter of the tower at approximately 15' +/- above grade

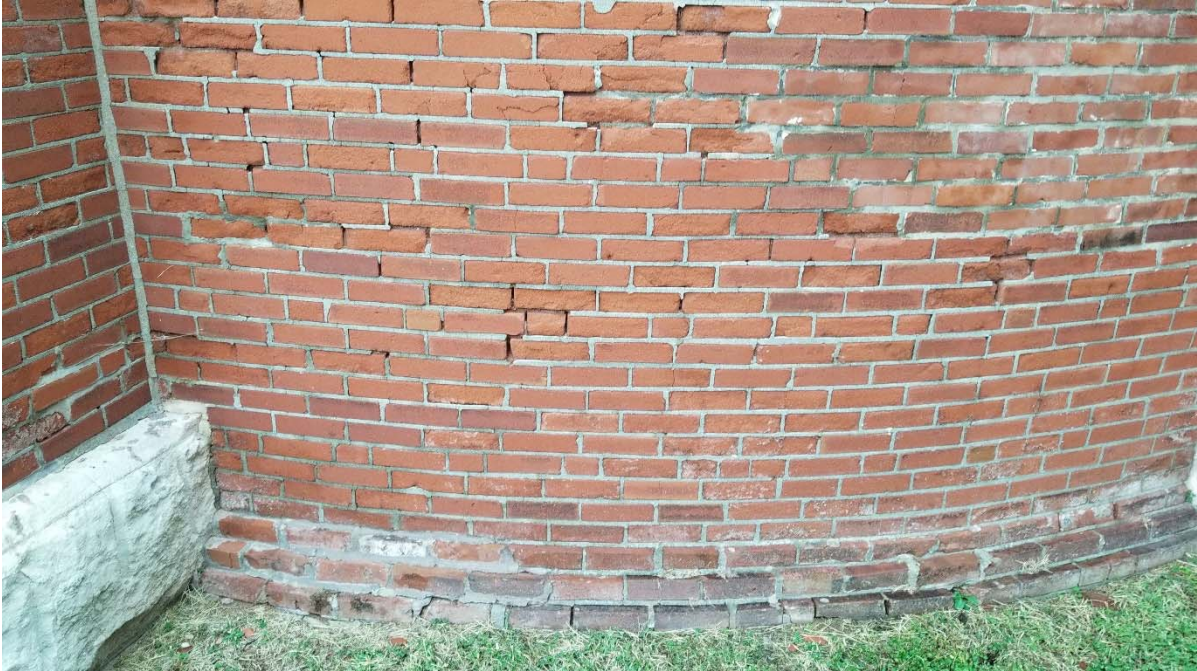
Photograph #3 – Photograph of spalled bricks and missing mortar on exterior surface of tower

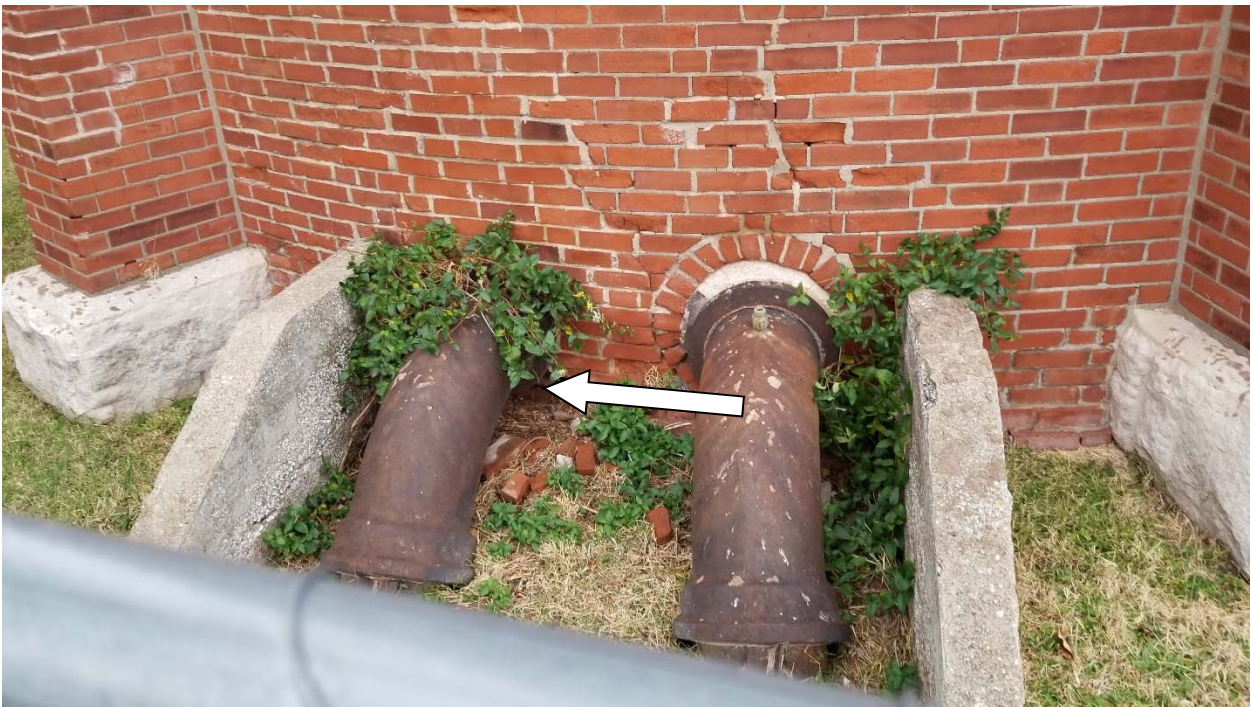
Photograph #4 – Photograph of loose bricks at base of tower

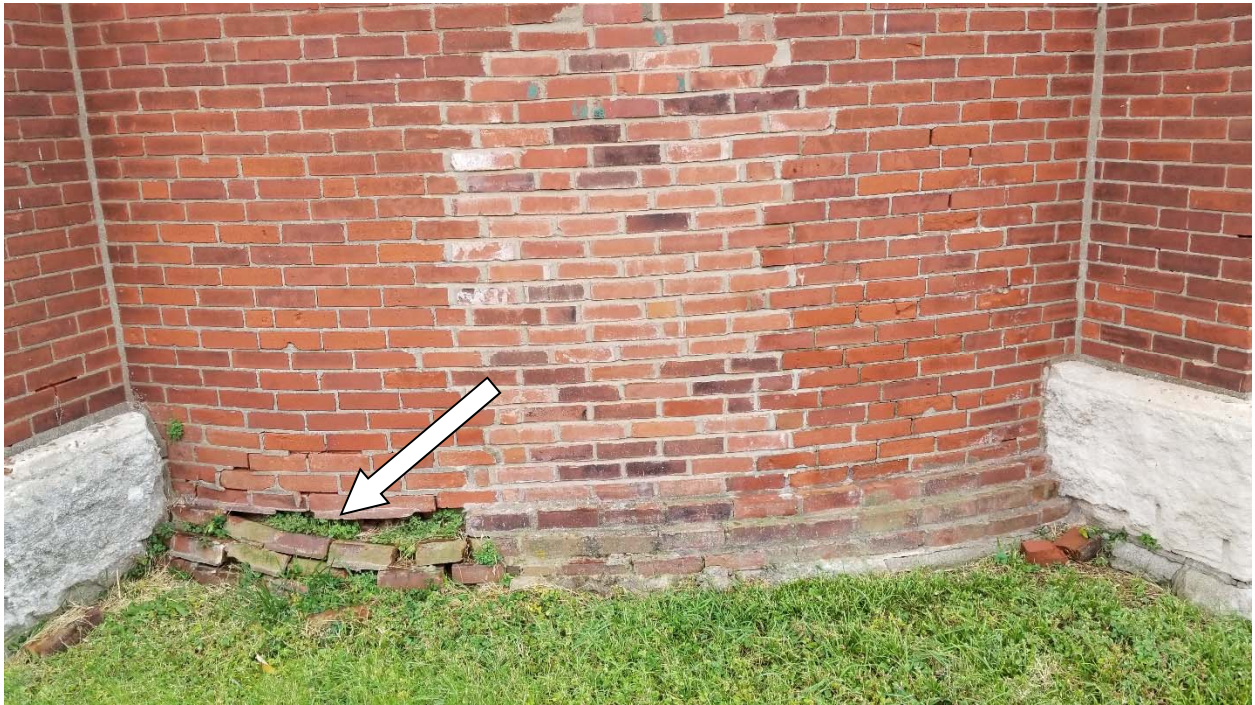
Photograph #5 – Photograph of loose bricks at base of tower

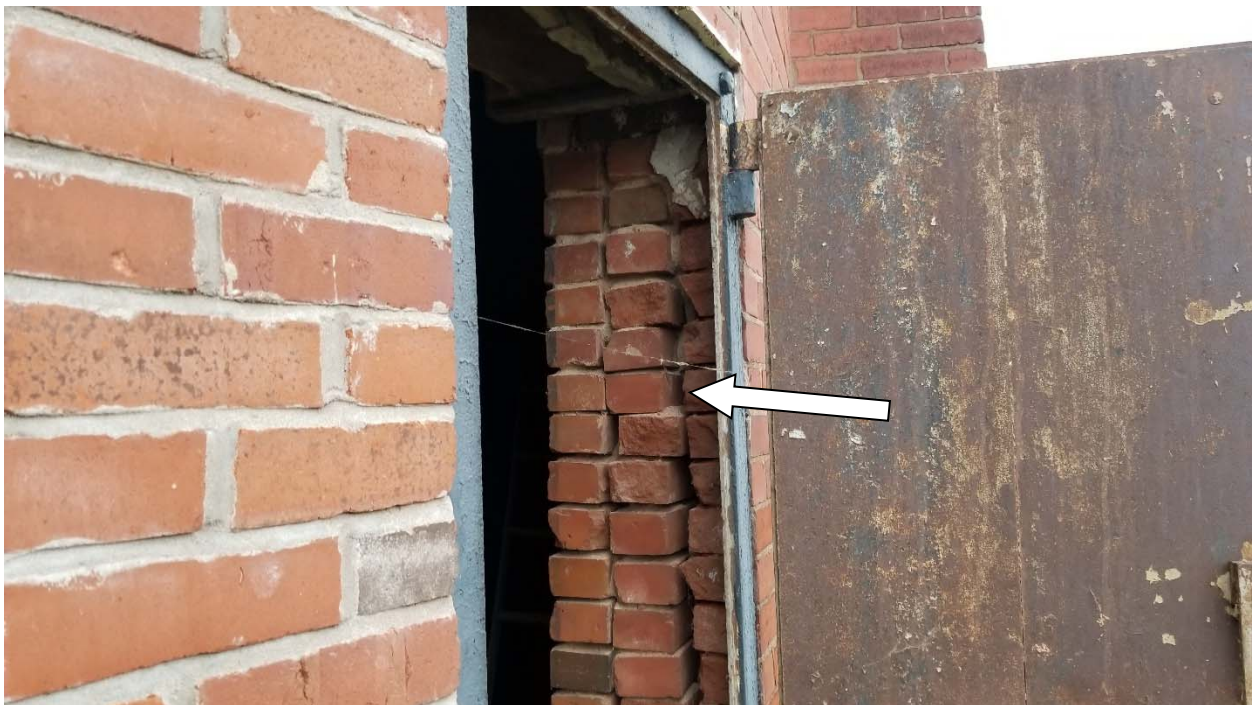
Photograph #6 – Photograph of loose bricks at edge of door opening. The mortar on the interior surfaces of the tower walls was deteriorated and large voids between the bricks were observed

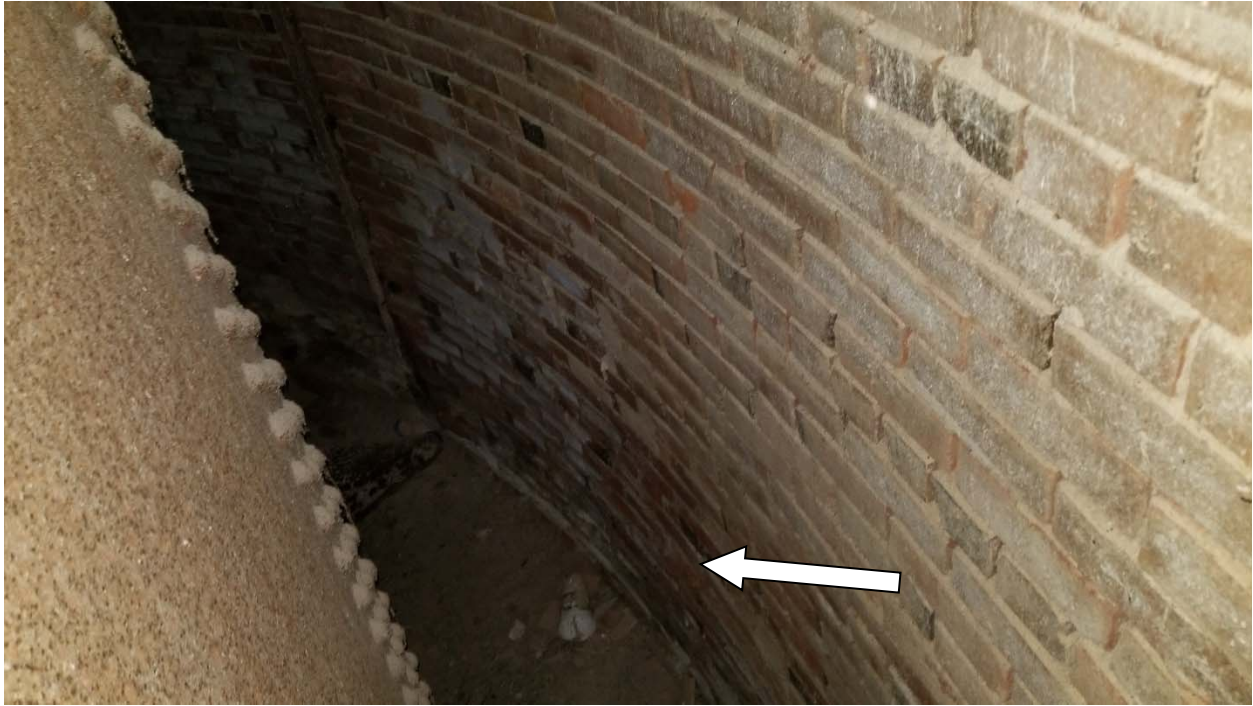
Photograph #7 – Photograph of deteriorated mortar joints on interior surface of tower wall. Lateral bowing was also observed at several locations on the interior surfaces of the tower wall

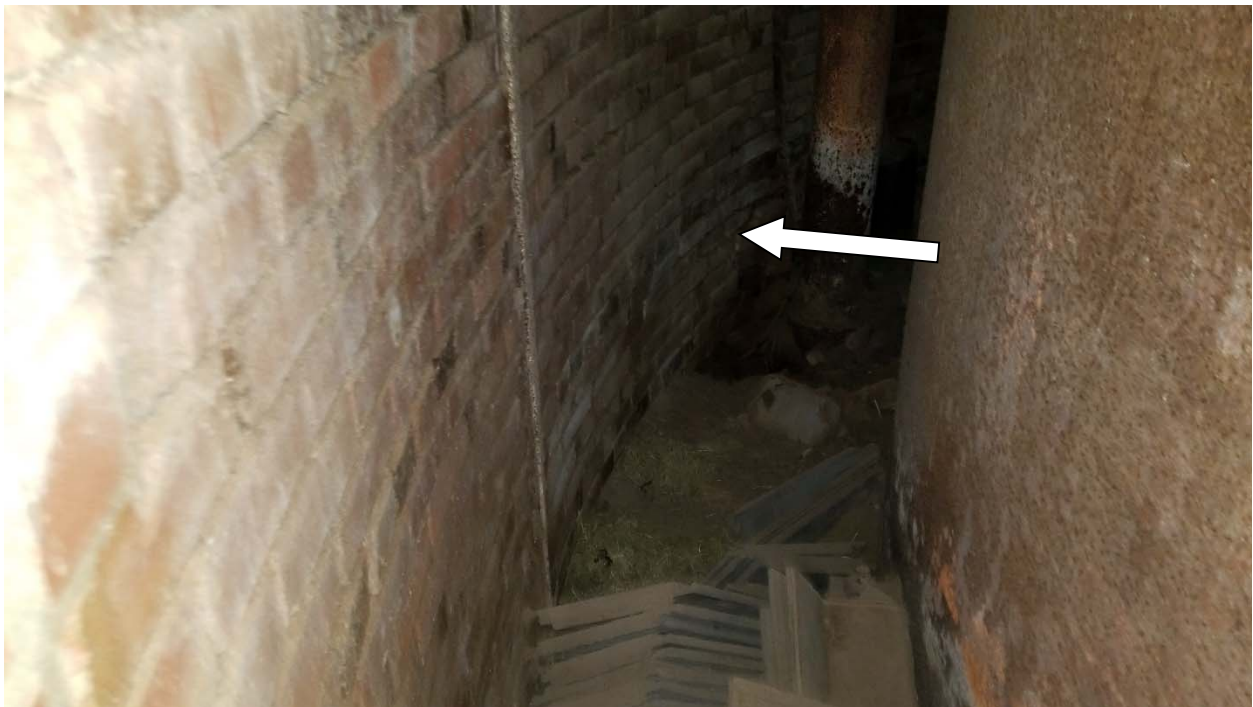
Photograph #8 – Photograph of loose bricks on interior surface of tower wall

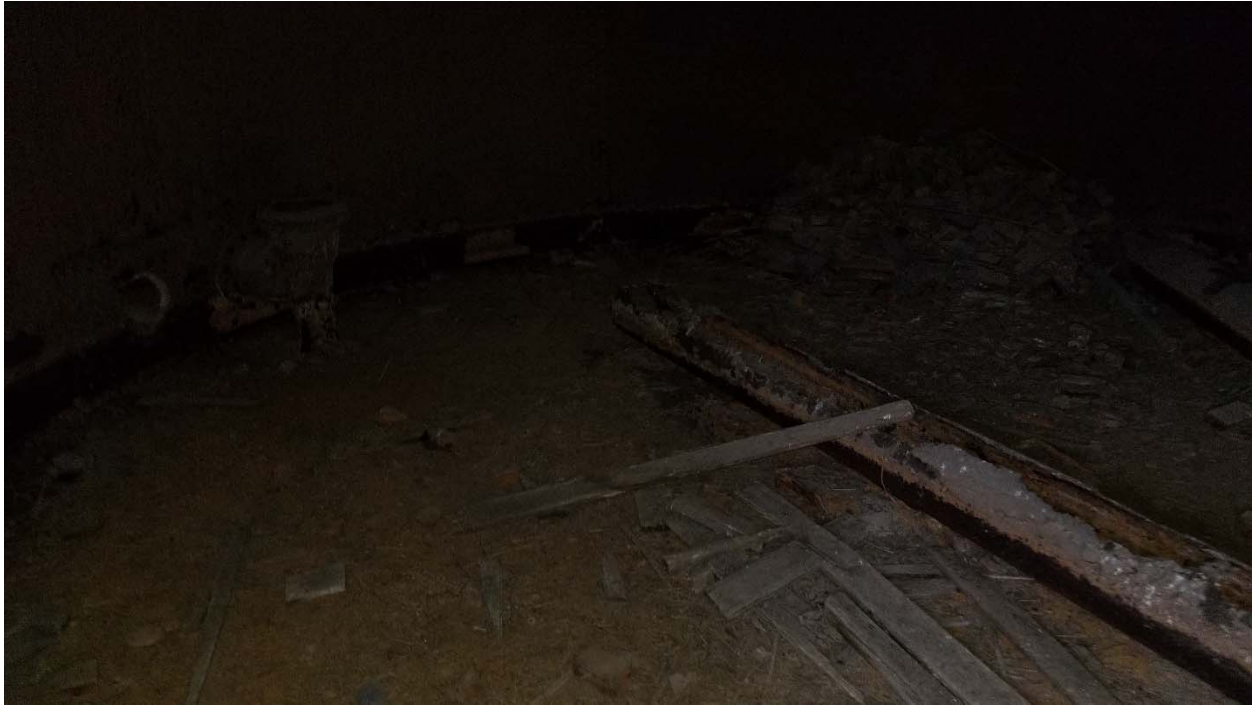
Photograph #9 – Photograph of brick, wood, and metal debris on the floor of the steel water tank.

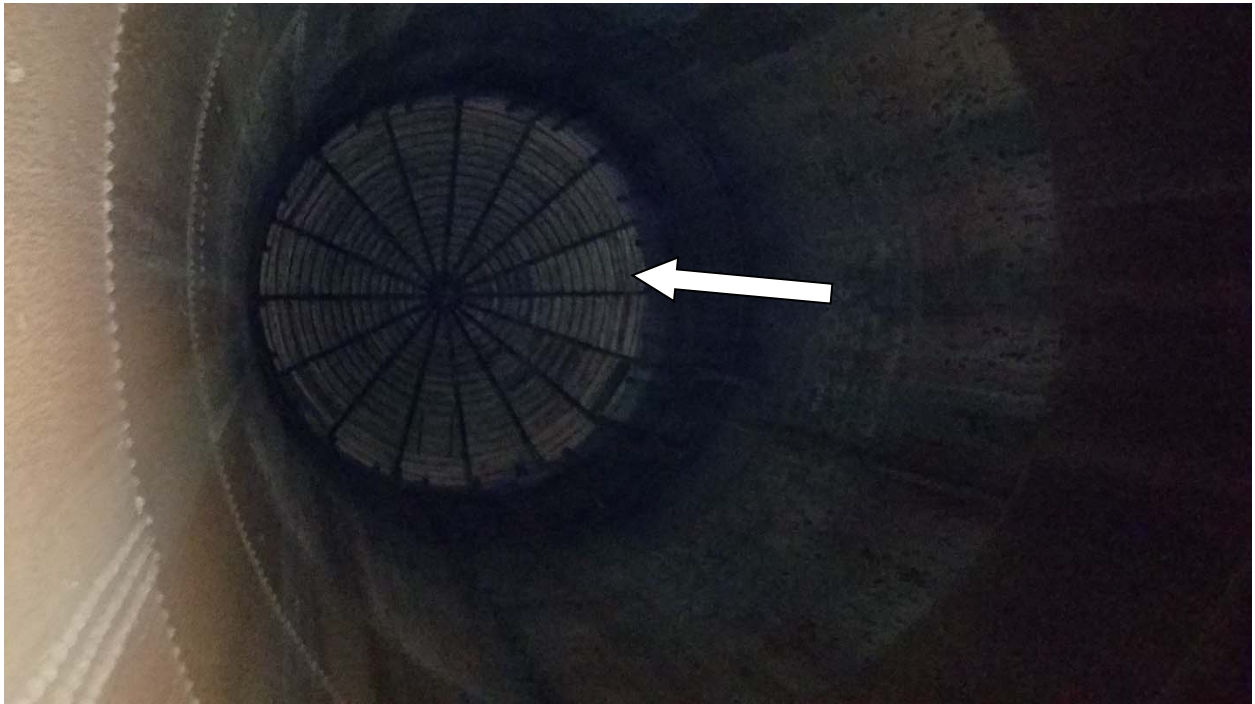
Photograph #10 – Photograph looking up at underside of wood roof deck viewed from inside of the steel water tank

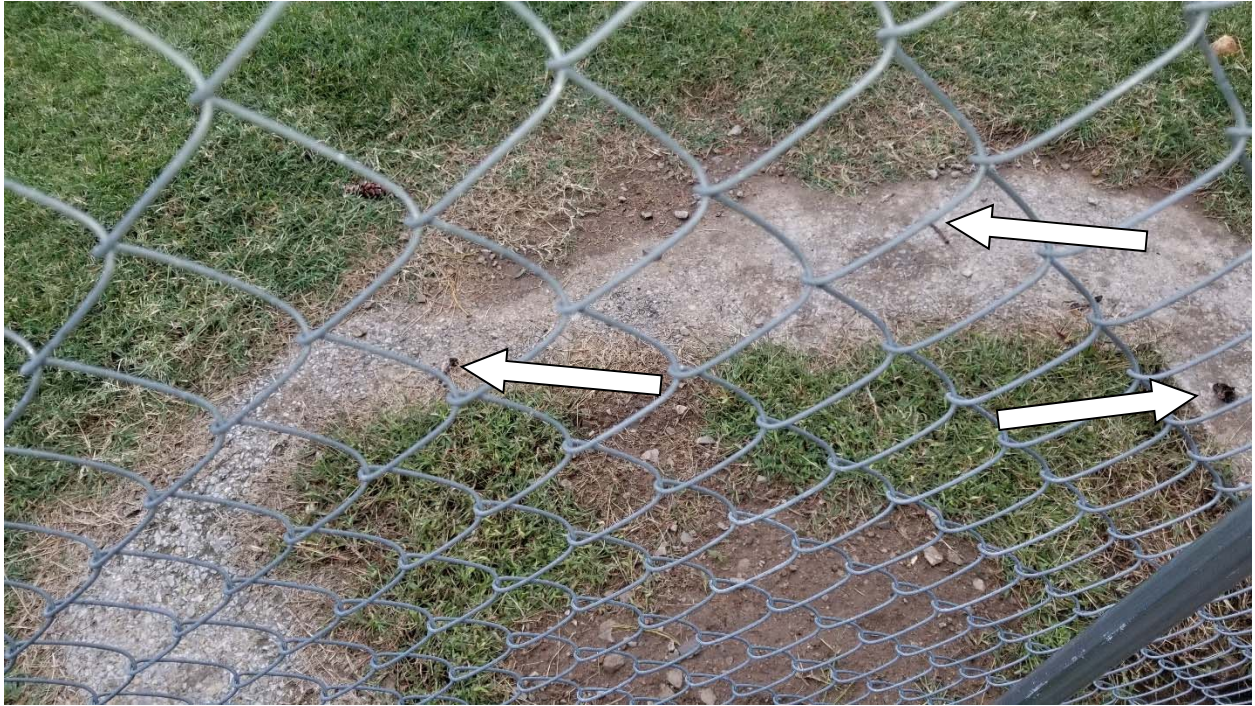
Photograph #11 – Photograph of nails, nuts, bolts, and other metal hardware on ground outside of fence at base of tower. The hardware appeared to have fallen from the wrought iron handrail and platform located at the roof of the tower
